# Industro-Foam Acoustic Treatment Case Study - April 2018

**Client:** Grass Roof Farm Stall – Mike & Nicky Charlewood (owners)

Location: Seaview, Port Elizabeth

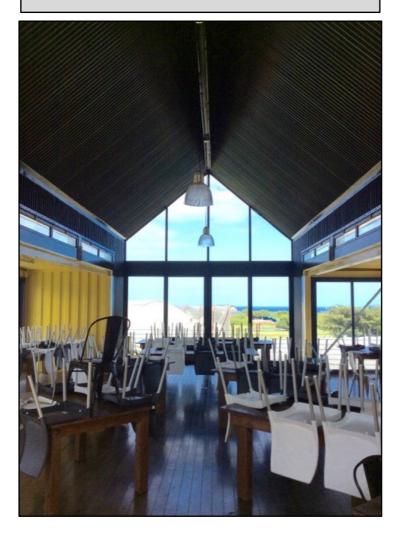
### **BEFORE**

**History:** The client experienced high levels of reverberation / echo in the overflow area at the restaurant, the fuller the restaurant got the worse the noise problem seemed to become. This was further exacerbated when the large glass sliding doors were closed. The problem had escalated to such an extent that patrons were leaving even before enjoying a meal. The owners approached Genesis Acoustics for help in order to improve the acoustics in the large space.
